Navajo Abandoned Uranium Mine

Site Screen Report

Mine Name: Starlight East
Mine ID: 180

April 2012

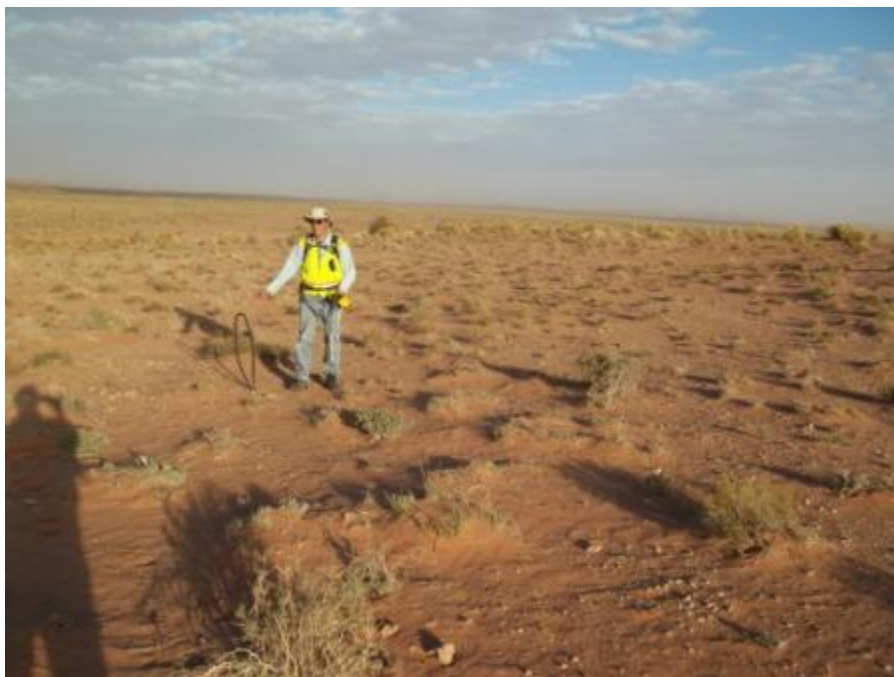
Photo 2

Possible mine shaft, as shown on Topo, appeared to be backfilled or covered.

Mine Site #180 – Former shaft area

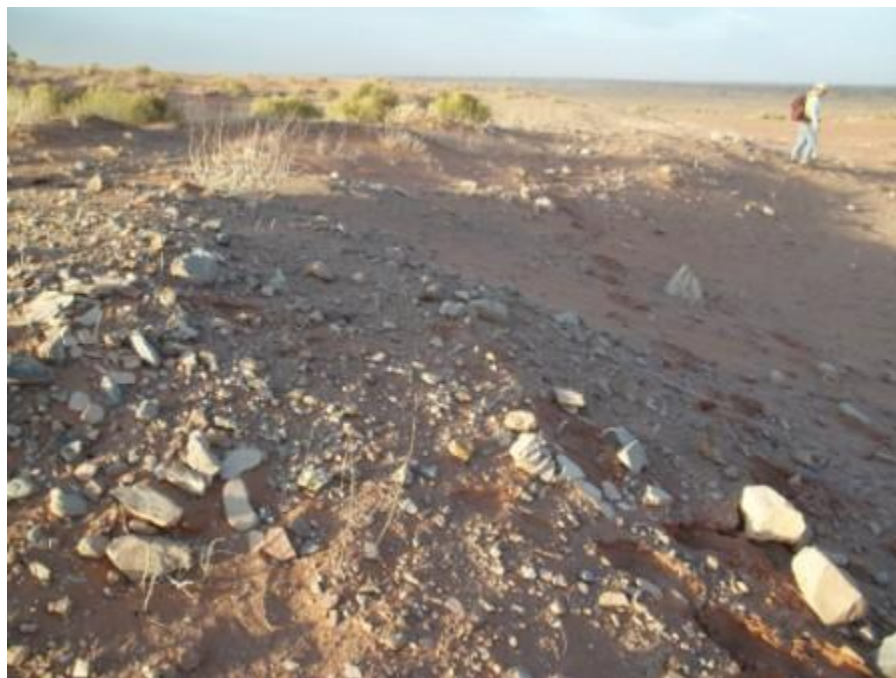
Photo 6

6 waste piles and scattered waste rock throughout the site

Mine Site #180 – Waste rock

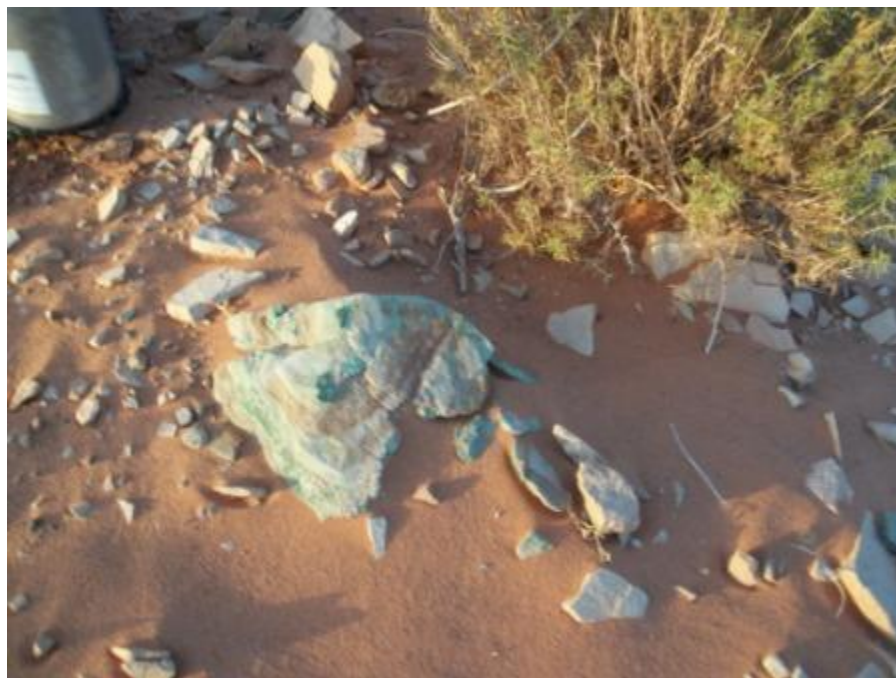
Photo 10

Mine Site #180 - Waste rock

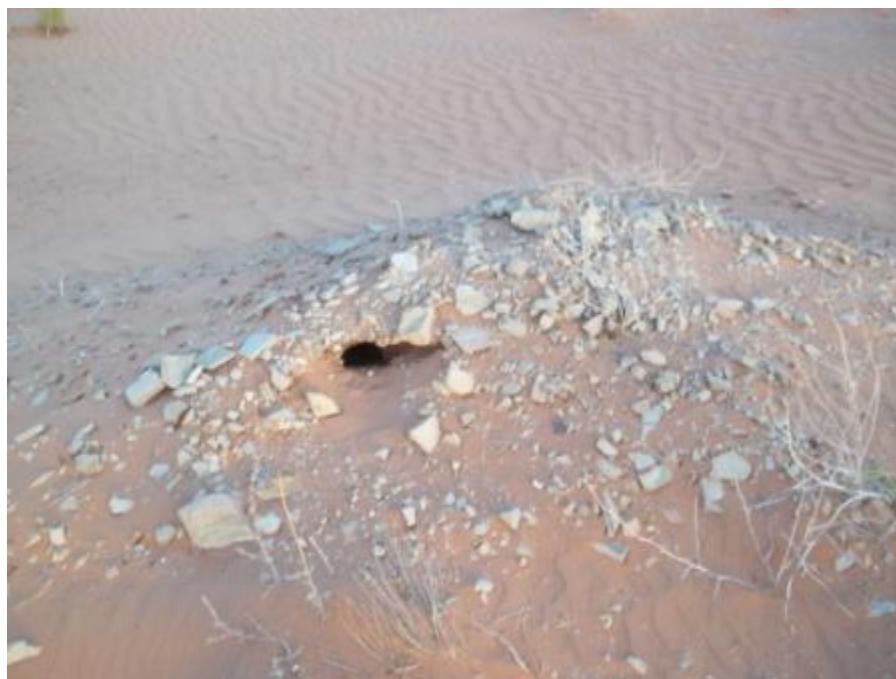
Photo 11

Mine Site #180 - Waste rock
